InSite Consulting Architects

Exterior Building Envelope Maintenance

Case Study #1

Elementary School District in Southeast Wisconsin – Building Envelope Failure Study

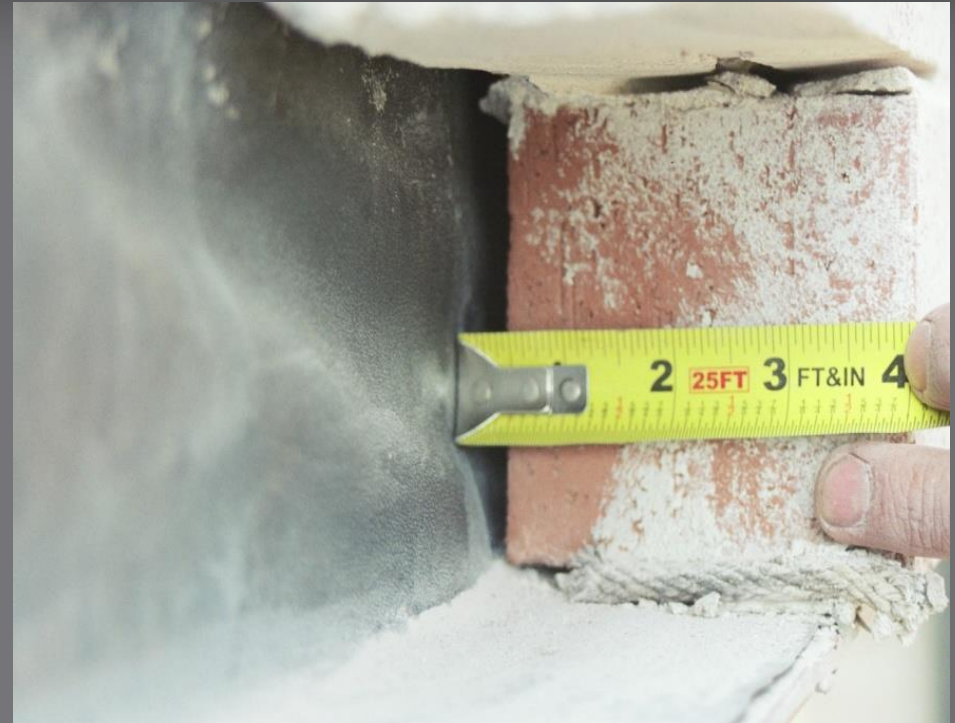
- Small Elementary School District in SE Wisconsin
- Persistent leak issues
- Mystery leaks
- Brick Damage (only 1 color of a 4 color blend)

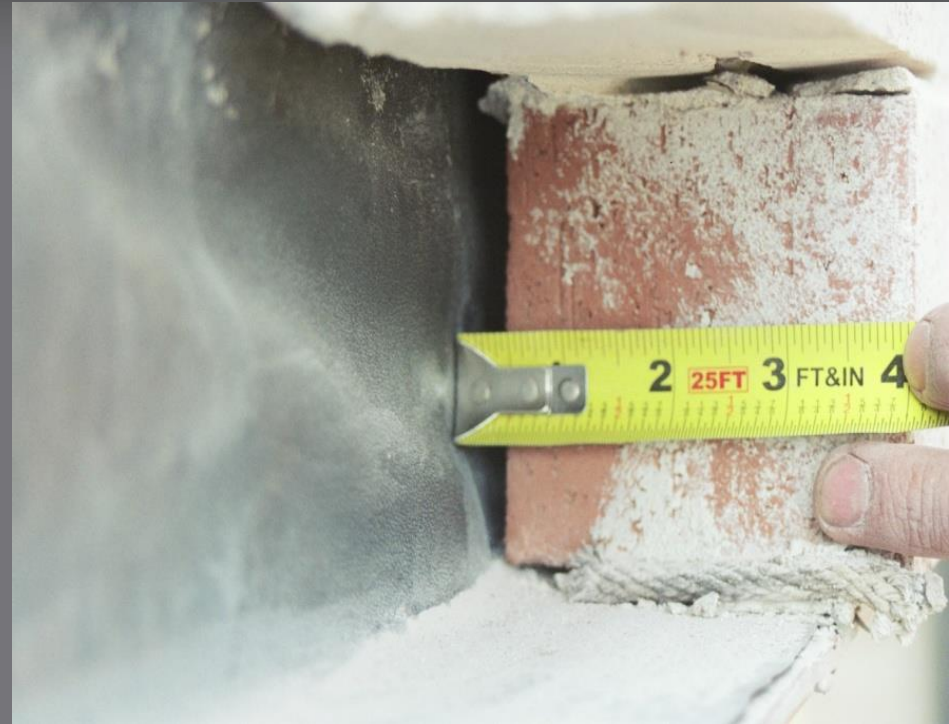
- No air space
- Head joint mortar incomplete
- Membrane not adhered
- Rope wick not installed properly

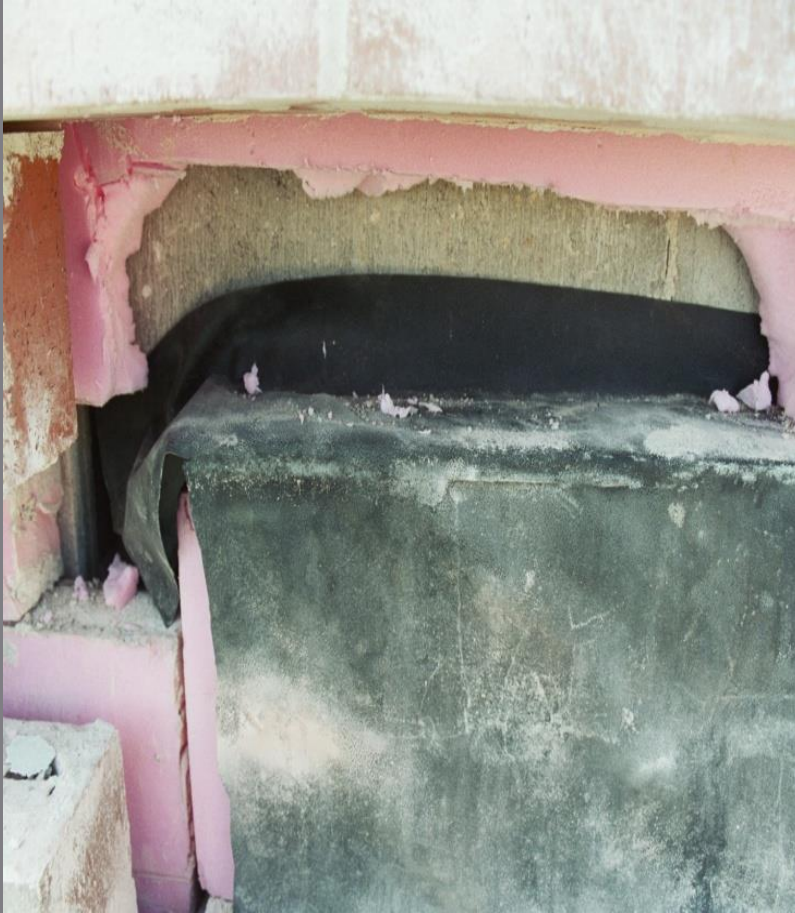
- Flashing not terminated properly
- Membrane unsupported
- Ends are turned down
- No end dams
- Flashing installed over insulation

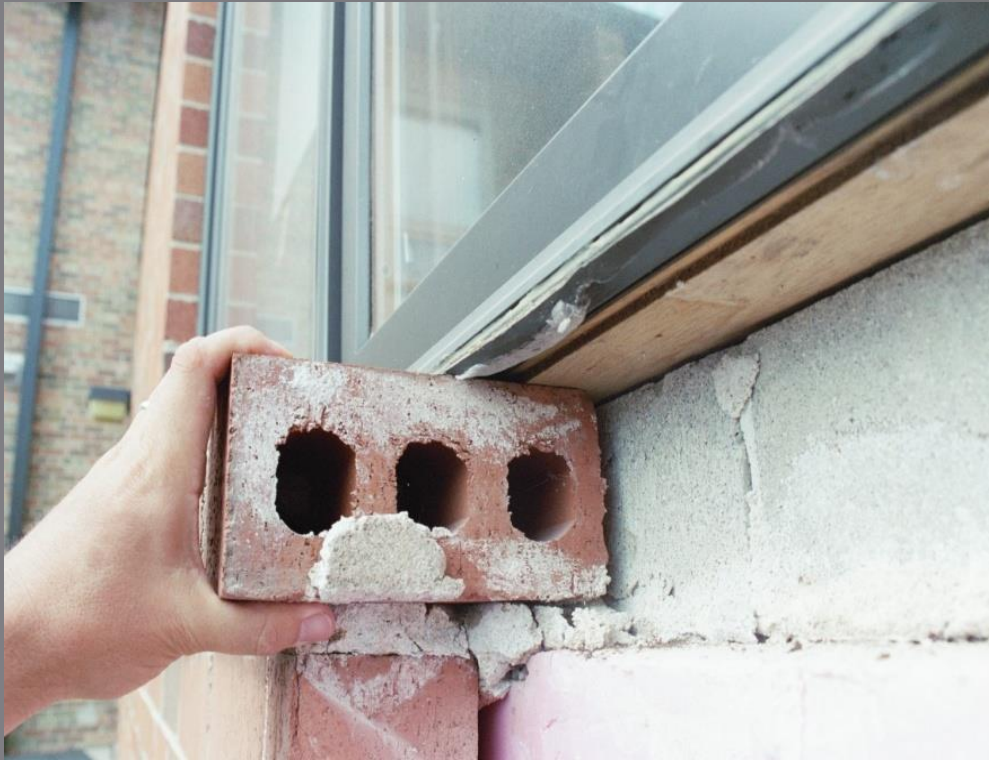
- No sill flashing
- Head joints not 'full'
- Bed joints not 'full'
- Brick sill, not good in WI
- Brick sill, no slope, not good anywhere

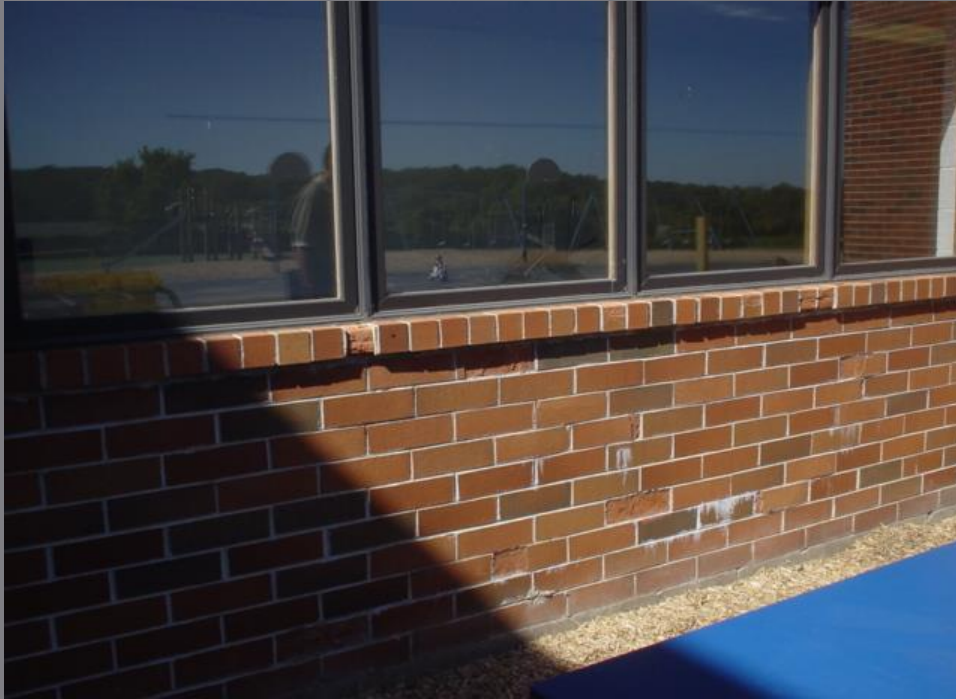
- Brick window sill back-sloped
- Brick spall at sill
- Efflorescence below sill
- Back-fill up to brick

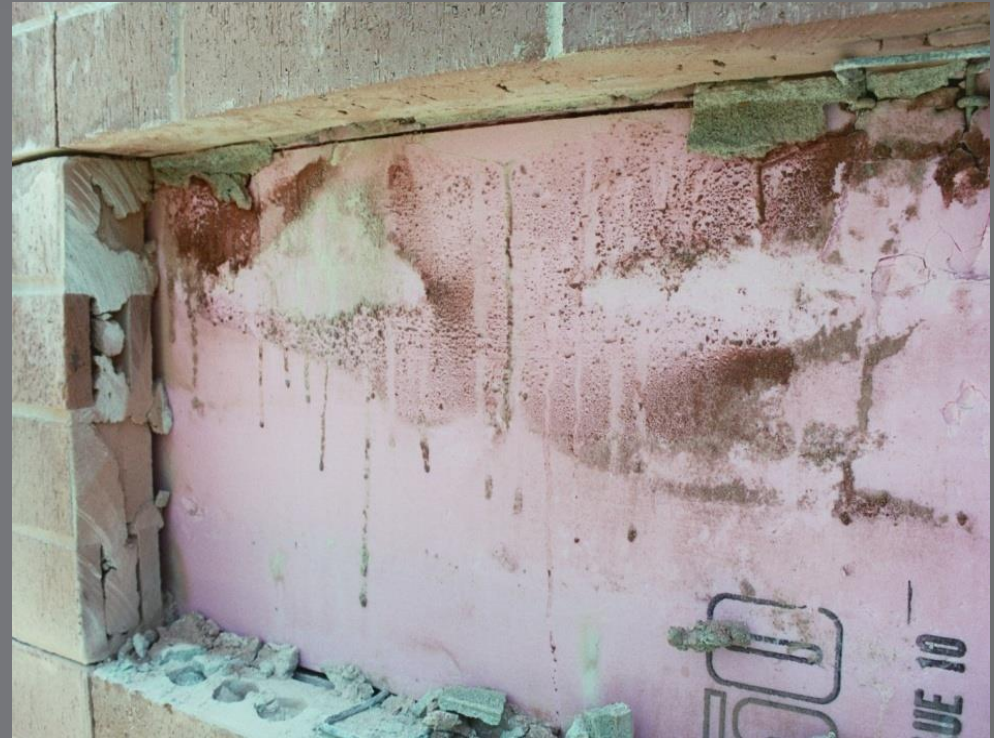
- No air space
- Head joints not 'full'
- Signs of prolonged liquid moisture

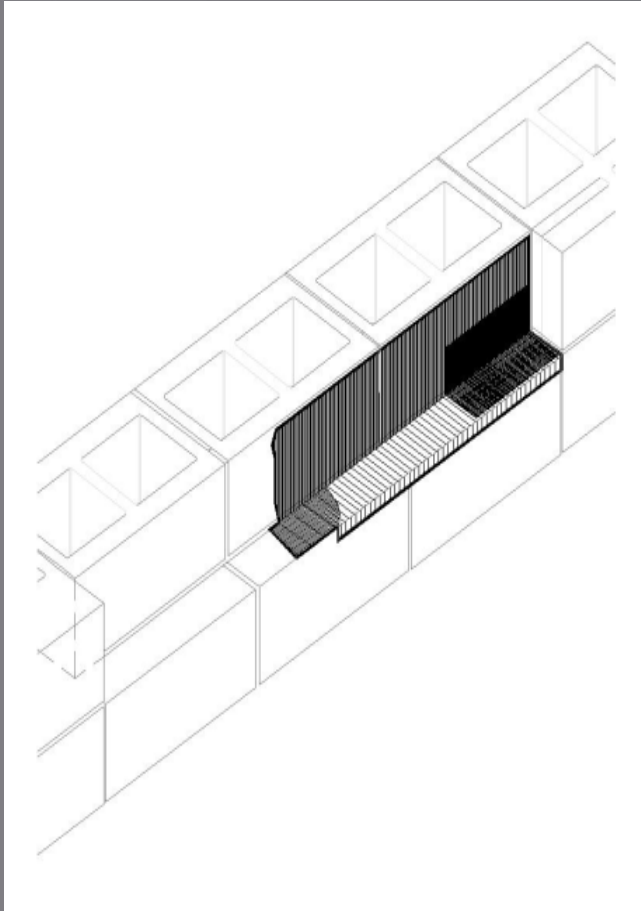
- Addition roof flashed into existing wall
- No through-wall flashing was installed
- Significant 'leaker' from day 1
- Because the wall was a single wythe, the assumption was made that a through-wall flashing could not be installed

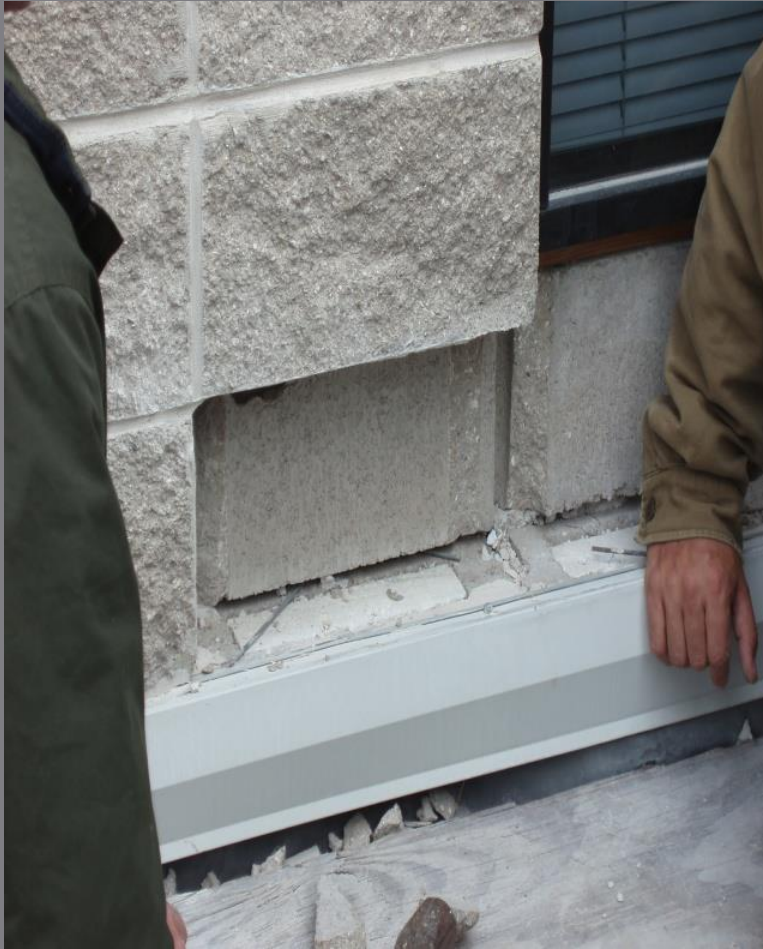
- Existing wall was a stacked bond split faced single wythe wall.
- The wall was investigated using invasive investigative techniques
- Findings: The single wythe block was an insulated 3 shell, 2 cell block
- The inside cell was cast with extruded polystyrene in its core
- The outside cell was a void
- Repair: The outside shell was removed and the center shell was prepared for the new through-wall flashing.

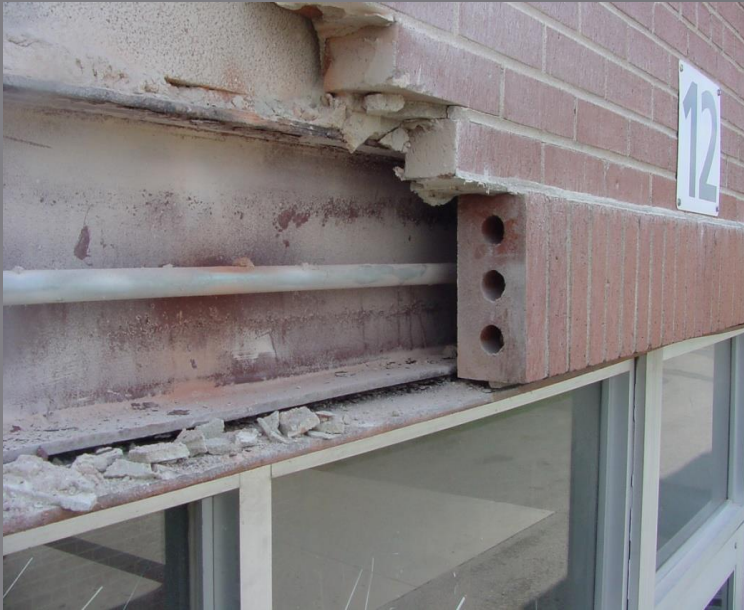
- View inside lintel construction
- Lintel extension has separated from the lintel beam
- No flashings were installed
- Water that passes through exterior wythe travels down to the lintel assembly
- Water passes through the wall at the bottom of the lintel, inside and out
- Corrosion and rust-jacking breaks the welds between the lintel and the lintel extension plate

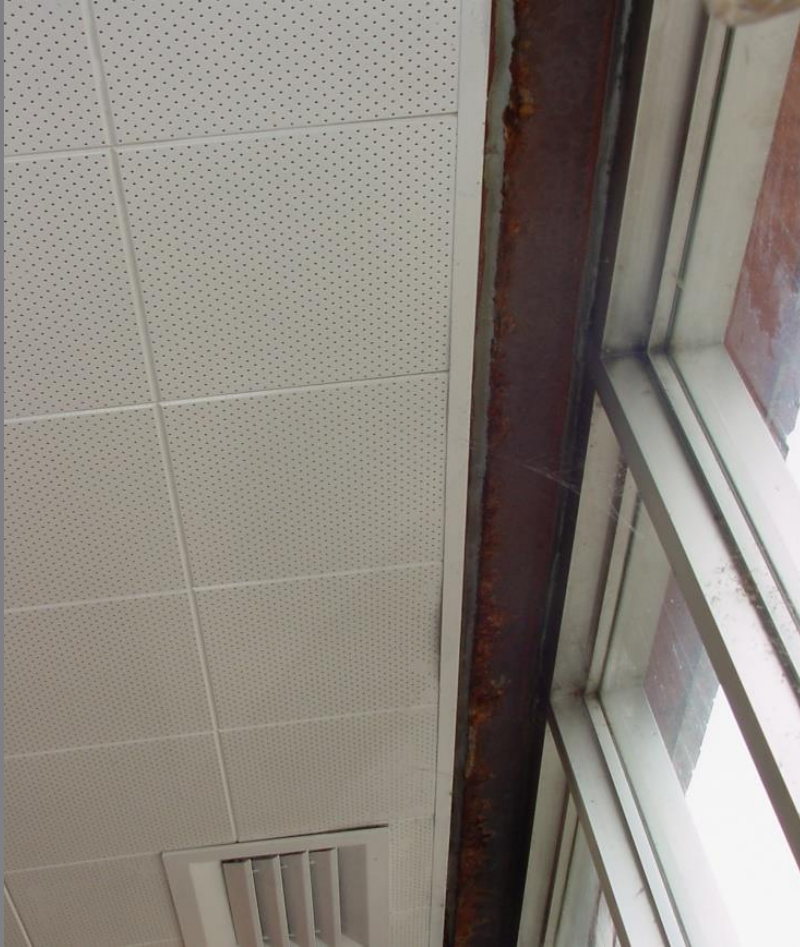
- View inside lintel construction
- Primary leak location at inside of lintel

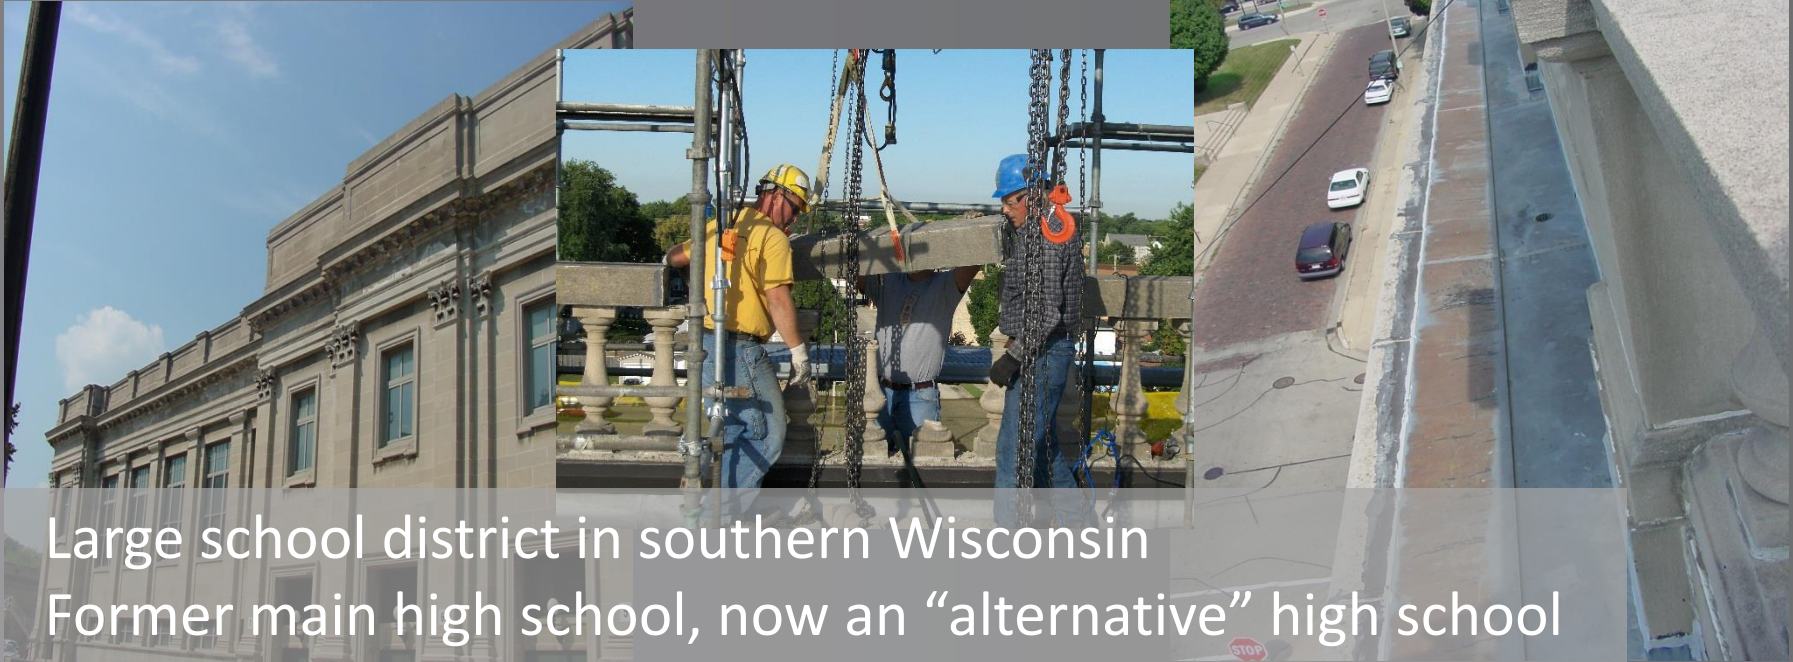
- Large school district in southern Wisconsin
- Former main high school, now an “alternative” high school
- Historic structure
- Significant cultural/emotional attachment to the facility
- Very large scale; city block in size
- Indiana Limestone deterioration noted in several areas
